## City Historic Buildings Survey

*Phase I: Evaluation of Historic Significance of City Buildings*

# **City Historic Buildings Survey Newton, Massachusetts**

### **Evaluation of Historic Significance of City Buildings**

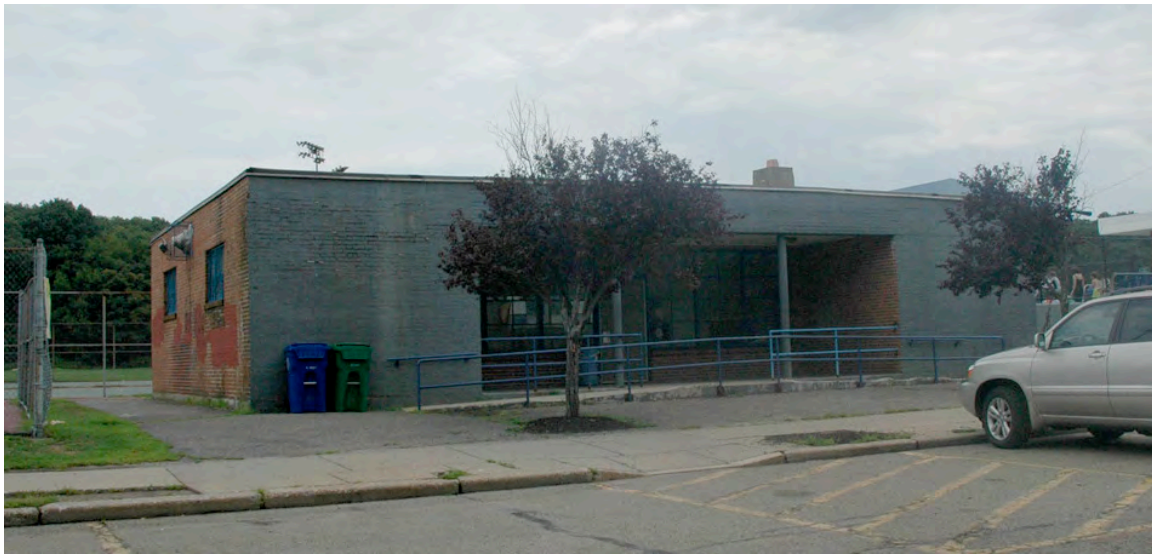
## Albemarle Fieldhouse

*Openings:* Large steel windows with divided-light sashes at the street elevation and smaller steel windows high in the wall at the side elevations (all likely original). Aluminum replacement door at entrance.

A well-designed utilitarian structure, but with few exterior architectural details. The building has not been well-maintained leading to loss of original material.

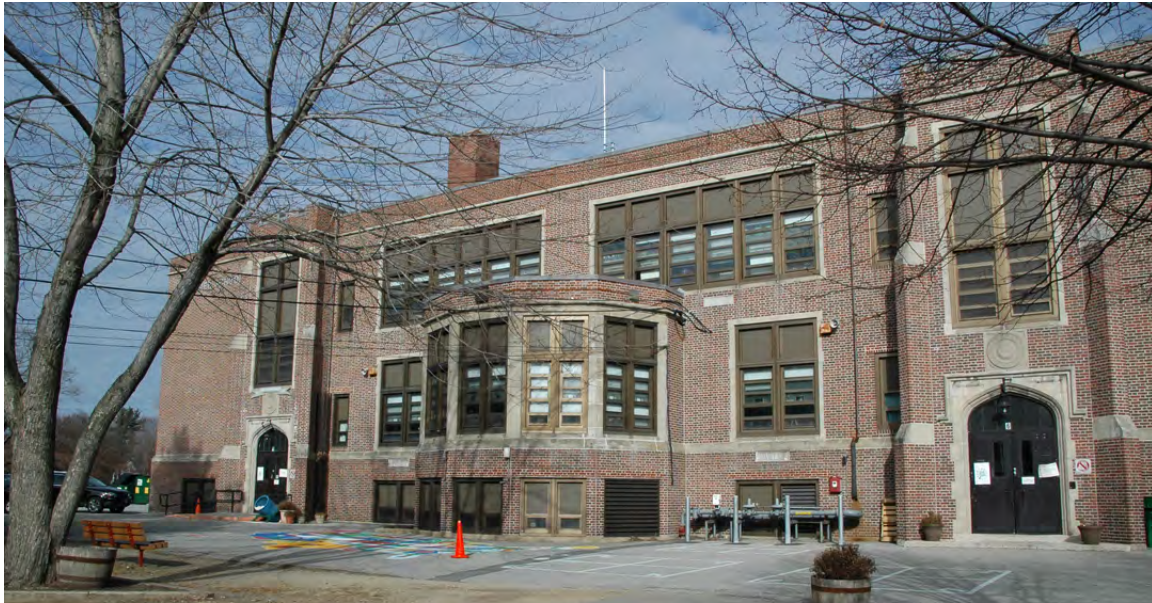
## Angier Elementary School

*Openings:* Typically single tall openings or bands of horizontal windows with replacement aluminum sashes within stone surrounds. The metal sashes are divided into multiple fixed sashes and operable hoppers with areas of aluminum infill at transoms and are jarring compared with the delicate original sashes seen in historic photos. Arched entrances with stone surrounds and aluminum doors located at the street elevation on either side of the bowed projection.

Moderate. The building retains the many of its original design features and materials. However, the replacement of the windows has greatly changed the appearance of the building.

A well-designed building of high-quality original building materials. Significant for its age relative to the majority of Newton's other school buildings.

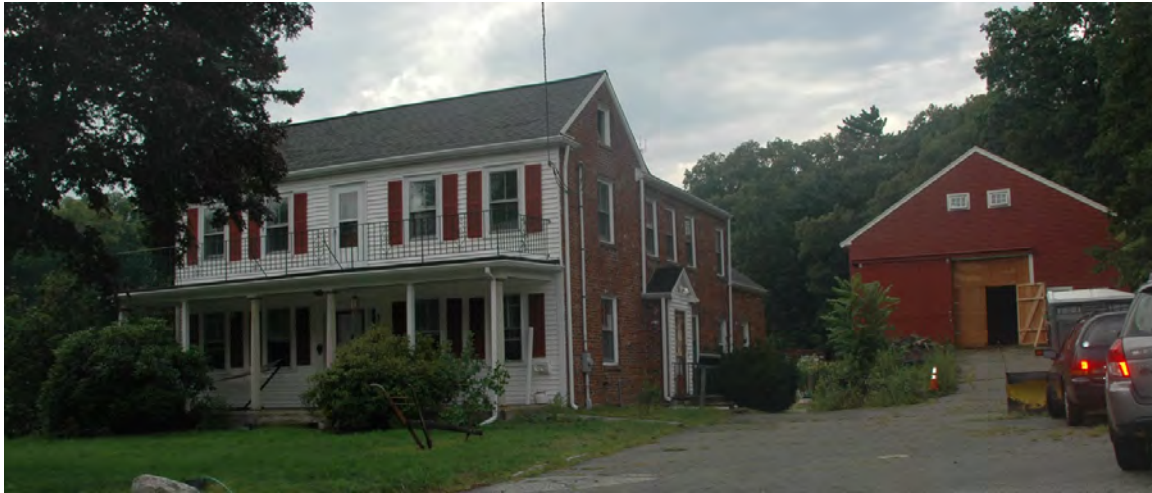
## Angino Community Farm

Significant primarily for its site, which still retains its setting as a working farm, and for its association with the Angino family.

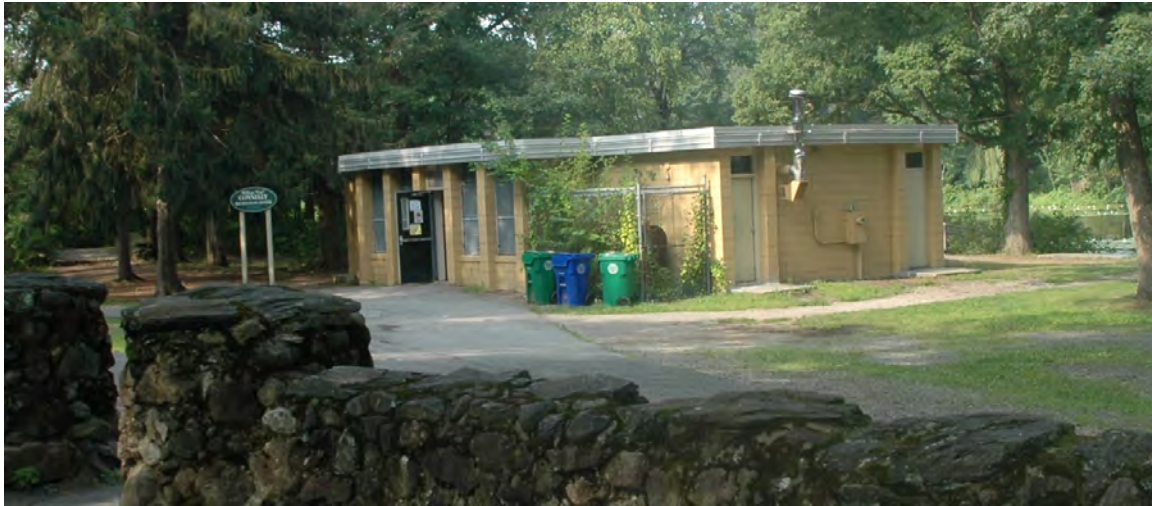
## Auburndale Cove Fieldhouse

Windows are set behind exterior metal grates. Aluminum replacement doors at each side with transoms.

Level 3 – Low Significance. The building is a primarily utilitarian structure with few architectural features.

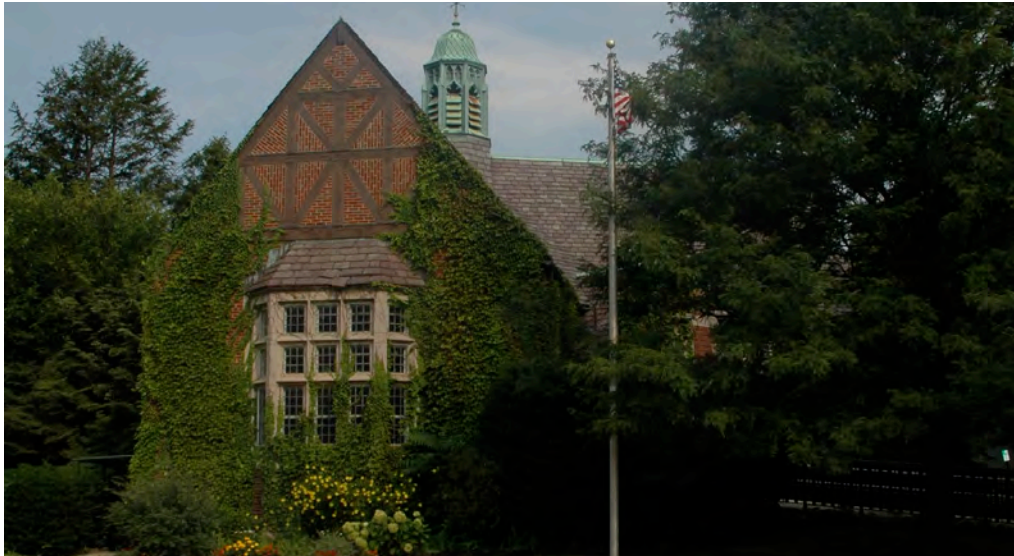
## Auburndale Library

*Openings:* There is a projecting bay window of leaded glass within a cast stone surround at the gable end facing Auburn Street. Other windows at the building are typically tripartite windows with steel casements filled with leaded glass and two sets of stacked leaded glass transoms. The main entrance is contained within an elaborate cast stone surround. The original door and arched transom have been replaced with a glass and aluminum entryway.

*Trim and Secondary Features:* Decorative rubble fieldstone is located at the sides of the chimney and at various intervals above the concrete foundation.

The building is a well-designed municipal structure and is part of an important civic movement in Newton. Individually listed building on the National Register.

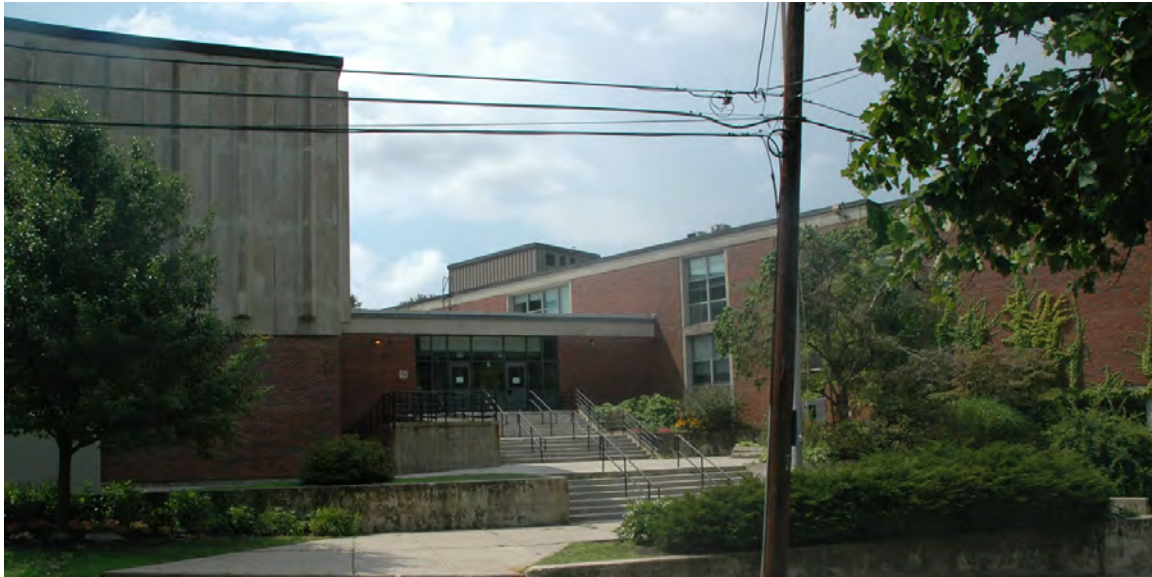
## Bigelow Middle School

*Shape:* A large conglomeration of one, two and three-story structures loosely organized around a central courtyard.

Not an exceptional example of its style and still of relatively recent construction.

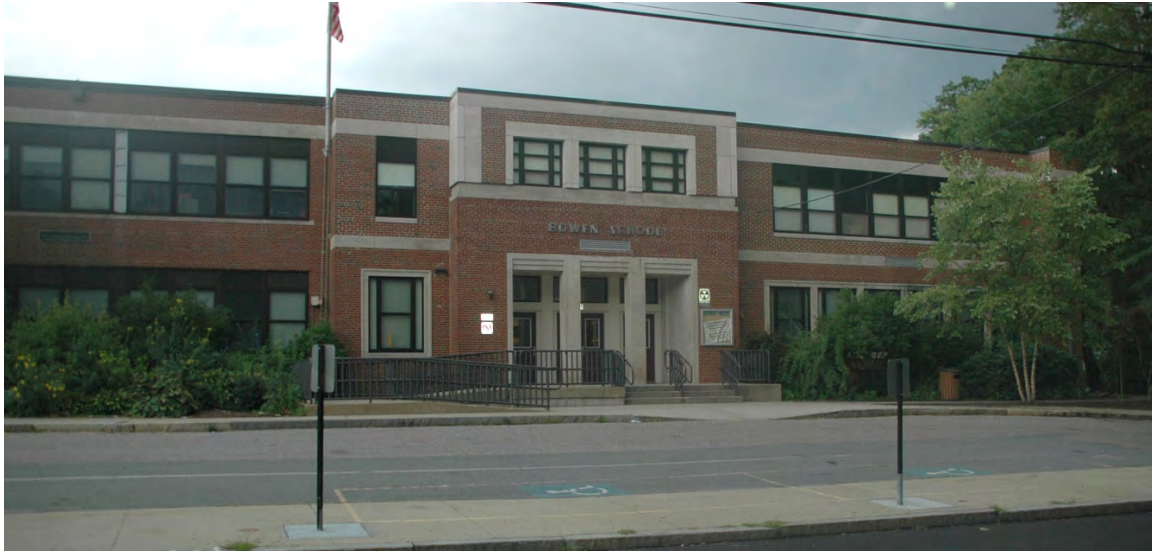
## Bowen Elementary School

*Openings:* Typically horizontal bands of double-hung windows with replacement aluminum sashes with aluminum infill panels. Three windows above the main entrance have an elaborate mullion pattern. Doors are aluminum replacements with transoms above.

Unique and elegant design for a school structure in Newton with high quality original building materials and a high degree of integrity.

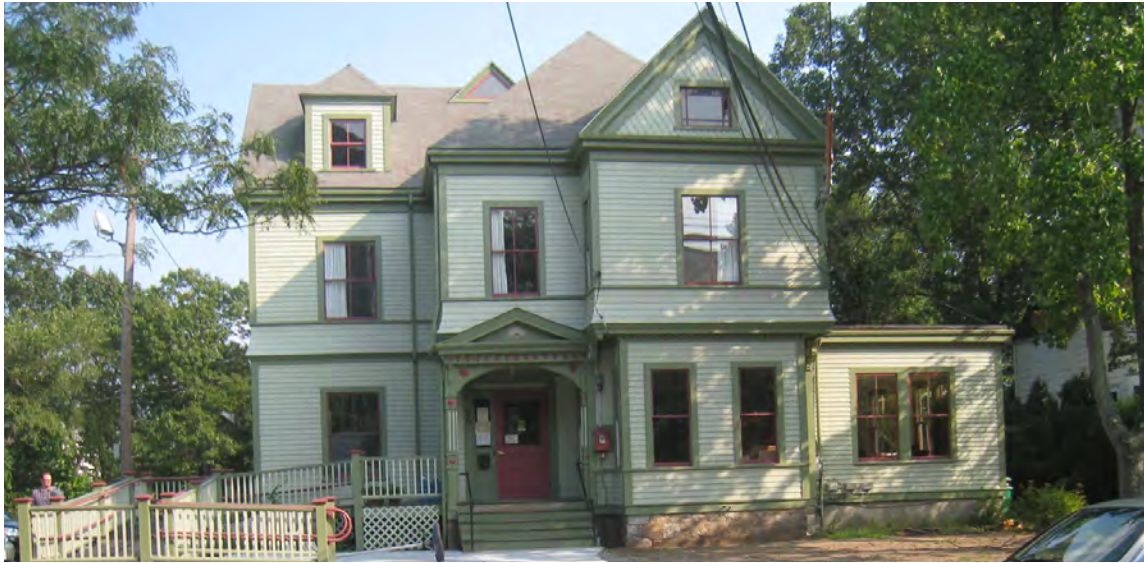
## Brigham House Community Center

*Materials:* Wood clapboard siding with wood trim. Decorative shingle siding at the gable ends and as a band above the first floor level. Stone foundation.

*Roof and Related Features:* Hipped roof with lower cross gables. Roof clad in asphalt shingles, likely a replacement for either slate or wood shingles.

*Openings:* A variety of opening shapes and sizes, typically containing wood single two-over-two double hung sashes or fixed sashes. The main entrance door is a modern replacement.

A contributing structure within the Newton Highlands National Register Historic District with a long association with the City of Newton.

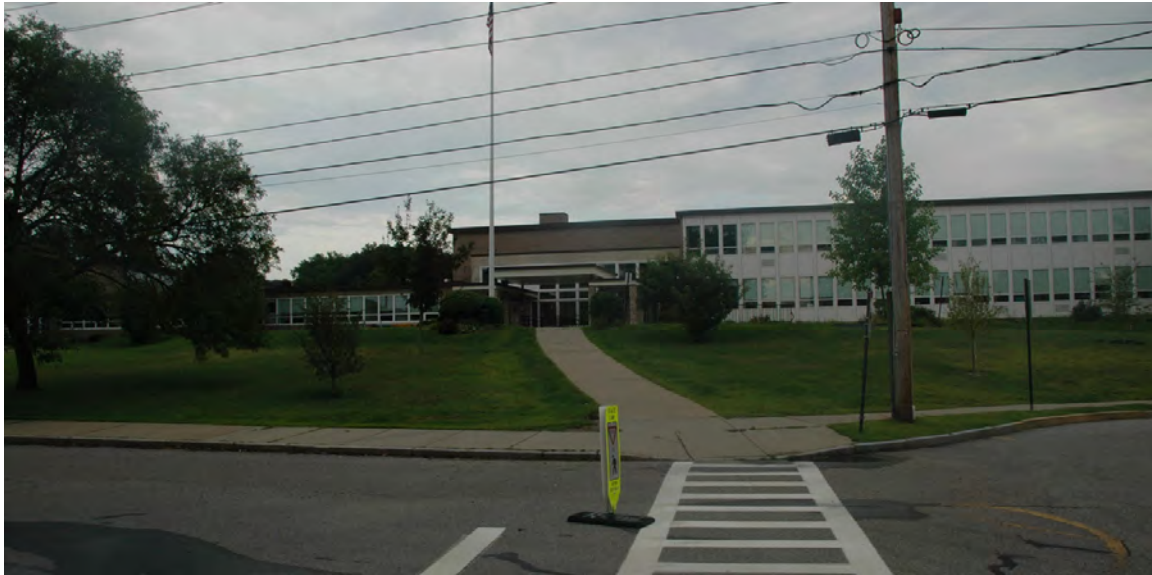
## Brown Middle School

*Materials:* Tan brick, stucco and glazed aluminum curtain wall at various locations. The curtain wall replaced the original steel, glass and multi-colored enameled panel walls of the original building.

Moderate. The building, particularly the original curtain wall assembly, has been greatly altered from its original appearance. Large additions were added to the building in 1962 and 1997 and the curtain wall was replaced in 2011.

The building has lost much of its original character through alterations.

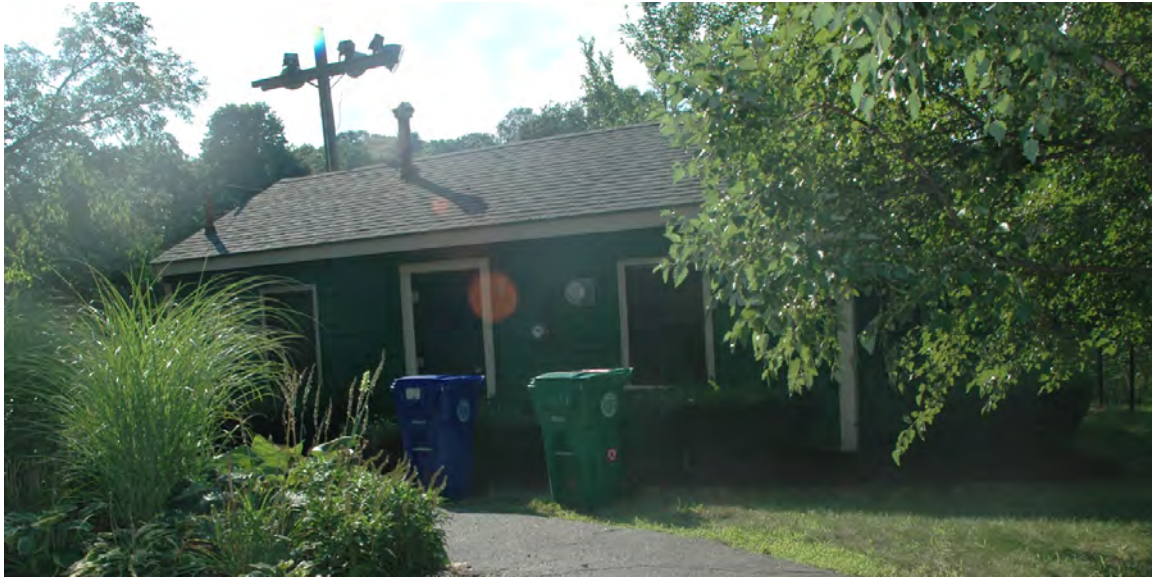
## Bullough's Pond Shelter

*Openings:* Four double hung 6-over-6 wood sashes, two at each side. Entrance door at street side has a wood door (likely a replacement).

Moderate. The date of construction given for the building is the mid 1960s, and it appears that the building has been altered. Possible alterations include the installation of the asphalt shingles where there was once likely wood shingles, replacement of doors and the porch structure, which appears to be of relatively recent construction, and likely replaces an original porch.

Level 3 – Low Significance. The building has few architectural details and has been altered from its original appearance.

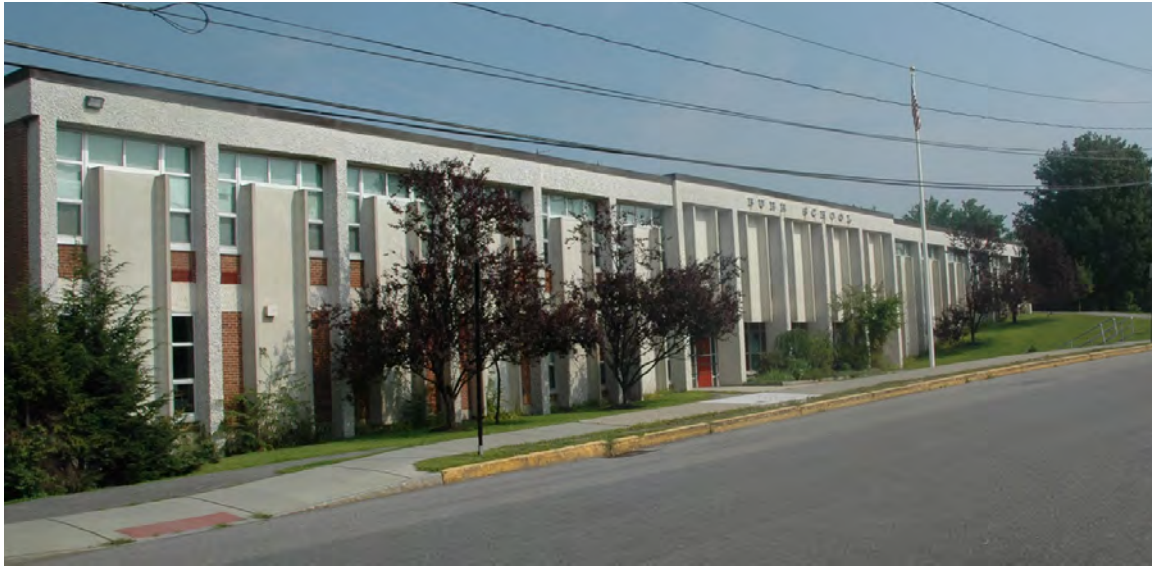
## Burr Elementary School

*Openings:* Curved bay window at the center bay facing the playing fields. Each projecting side bay on the field side has a tripartite window with a center 6-over-6 double-hung sash with 2-over-2 sidelights. The side of the building facing the playground has additional 6-over-6 sashes. Two arched doorways are located on the playing field side that have replacement aluminum doors. The larger entrance door facing the playground has an arched doorway with a replacement aluminum door and transom.

An elegant structure with high-quality materials designed by a well-known architect and an important feature within the park landscape.

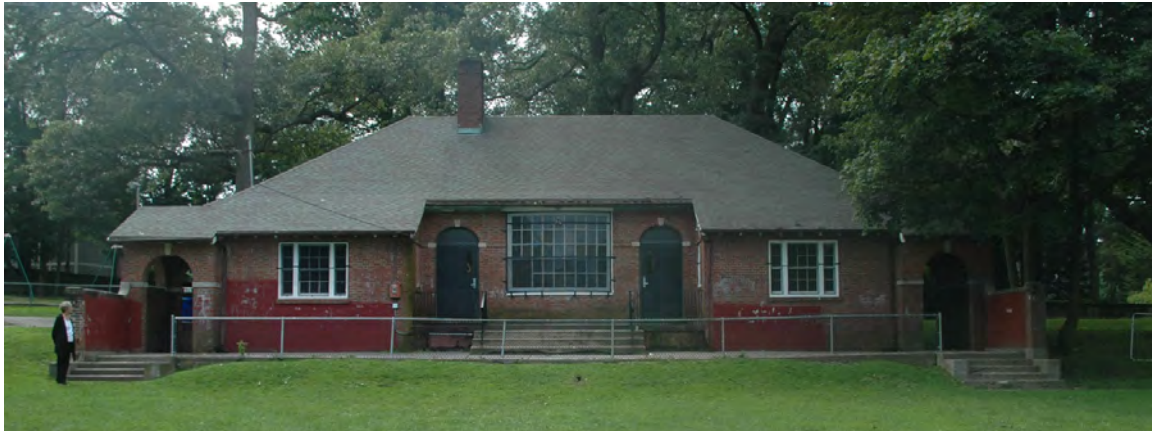
## Burr Park Fieldhouse

Address: 142 Park Street  
Year of Construction: 1919

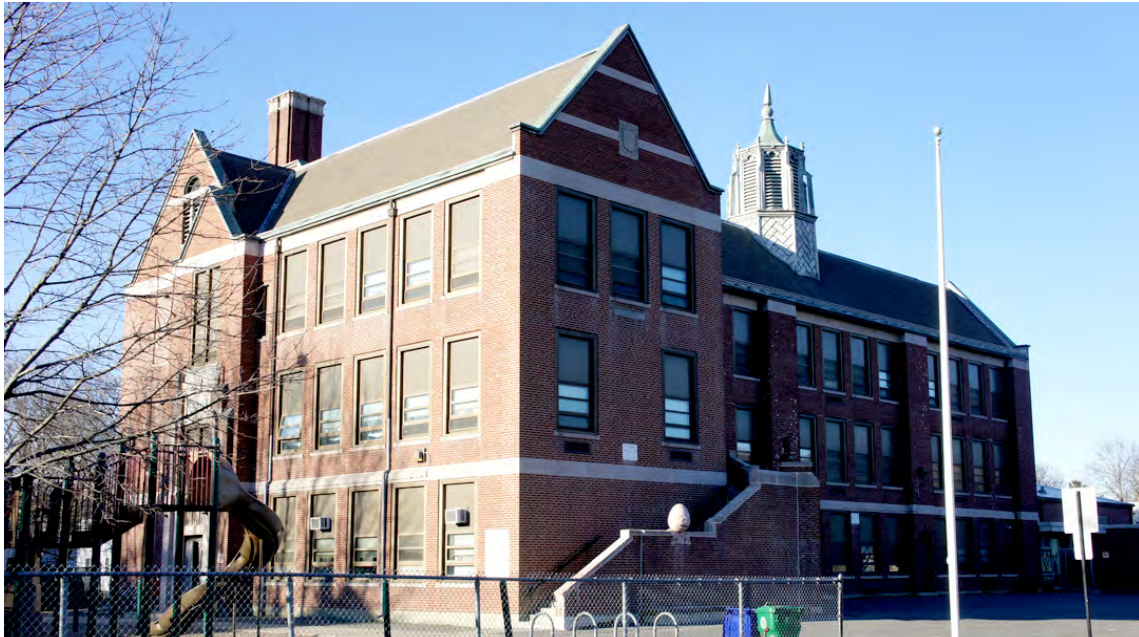
## Cabot Elementary School

Public elementary school adjacent to Cabot Park designed in the Tudor Revival style by architects Charles R. Greco and W. B. Hollings. A large addition was added at one side of the building in 1956 and the original windows were replaced with aluminum windows in the 1980s.

*Materials:* Brick with cast stone trim and concrete foundation.

*Openings:* Typically single openings with replacement aluminum sashes divided into stacked horizontal sashes with two fixed sashes and one operable hopper and a large infill panel at the top of the opening. The replacement windows are dramatically different from the original sashes, which were large wood 12-over-12 double-hungs. The main entrance has replacement aluminum doors set within an elaborate cast stone surround.

Moderate. The building retains many of its original design features and materials. However, replacement windows have greatly changed the appearance of the building.

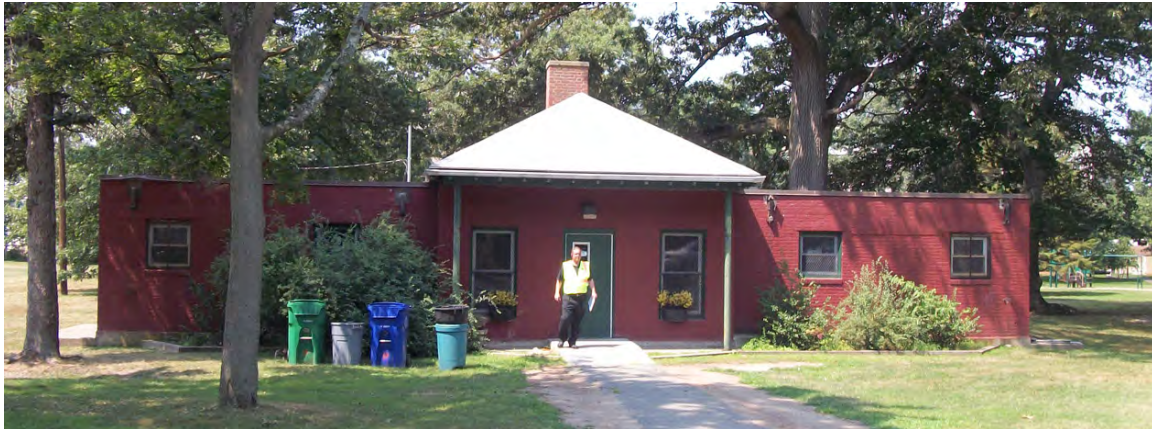
## Cabot Park Fieldhouse

Address: 101 East Side Parkway  
Year of Construction: 1926

*Materials:* Painted brick with concrete foundation.

*Roof and Related Features:* The square center section has a hipped roof with exposed wood brackets. The roof is clad with asphalt shingles, likely a replacement for slate. The two side wings have flat roofs with aluminum fascias. Gutters are modern aluminum.

*Openings:* The front of the building has individual openings with replacement aluminum double-hung sashes covered with metal security grilles. Original openings at the rear of the building have all been infilled with brick or plywood.

*Projections:* The hipped roof overhangs the front and rear elevations of the building wall creating covered porches at both sides. Painted steel columns, replacements for the original wood columns, support the edge of the roof. A masonry chimney is present at the rear side of the hipped roof.

Moderate. The structure has been altered since its original construction, changing its appearance. Changes include infilling of window openings, replacement of the original wood columns and window sashes and roof and painting of the brick.

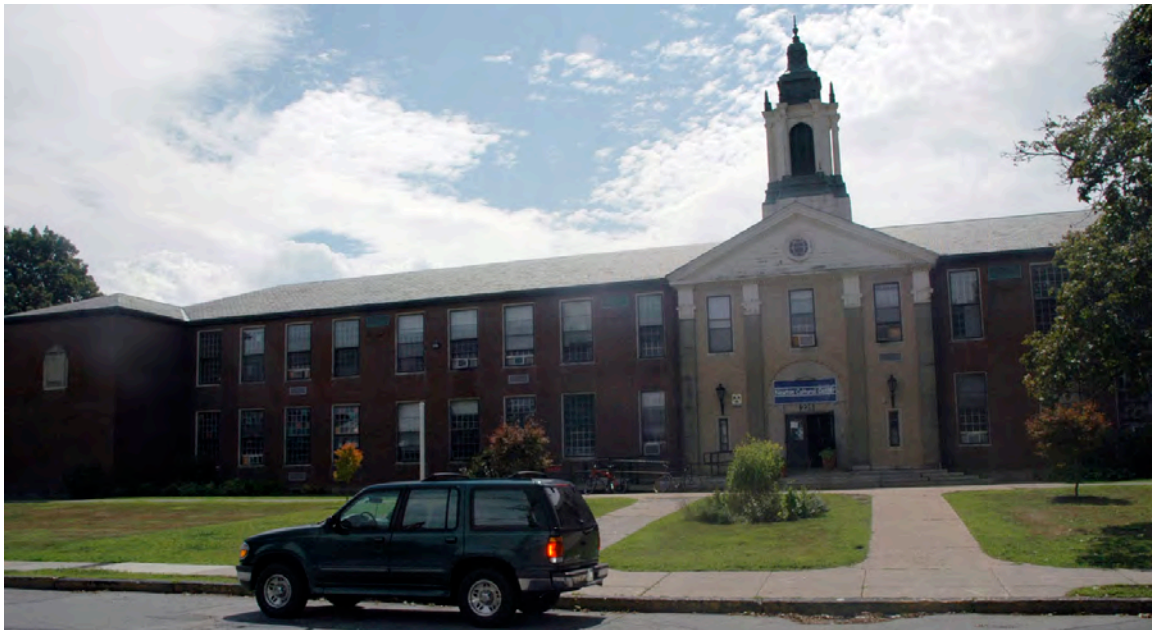
## Carr School

*Openings:* Typically regularly-spaced window openings with 20-over-20 wood sashes. Exterior doors are aluminum replacements.

Moderate. Still retains many of its original materials and design features, however the quality of some of the original building materials and poor maintenance have caused some features to deteriorate. The modern addition does not overwhelm the original structure.

An important civic structure in Newton that was recognized as architecturally significant at construction. Individually listed building on the National Register.

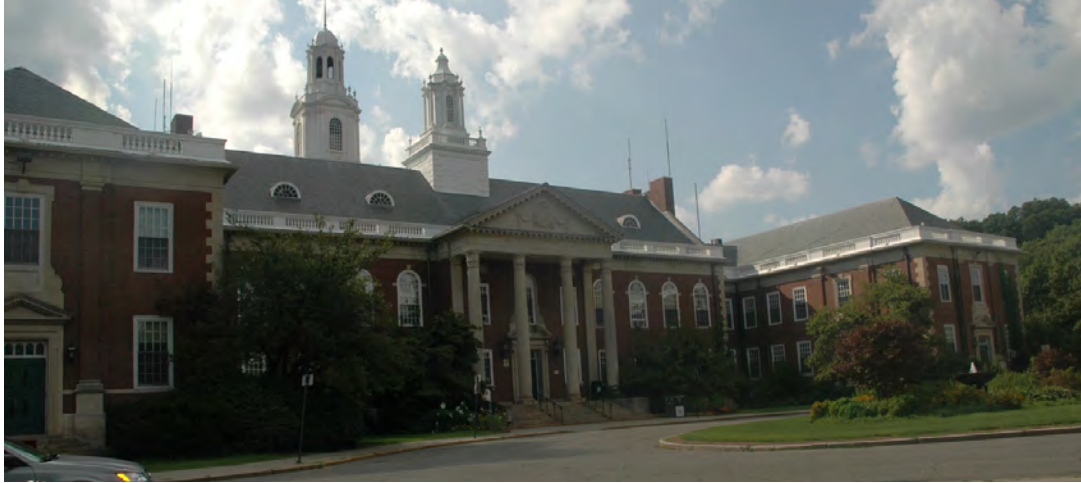
## City Hall

Address: 1000 Commonwealth Avenue

Year of Construction: 1931

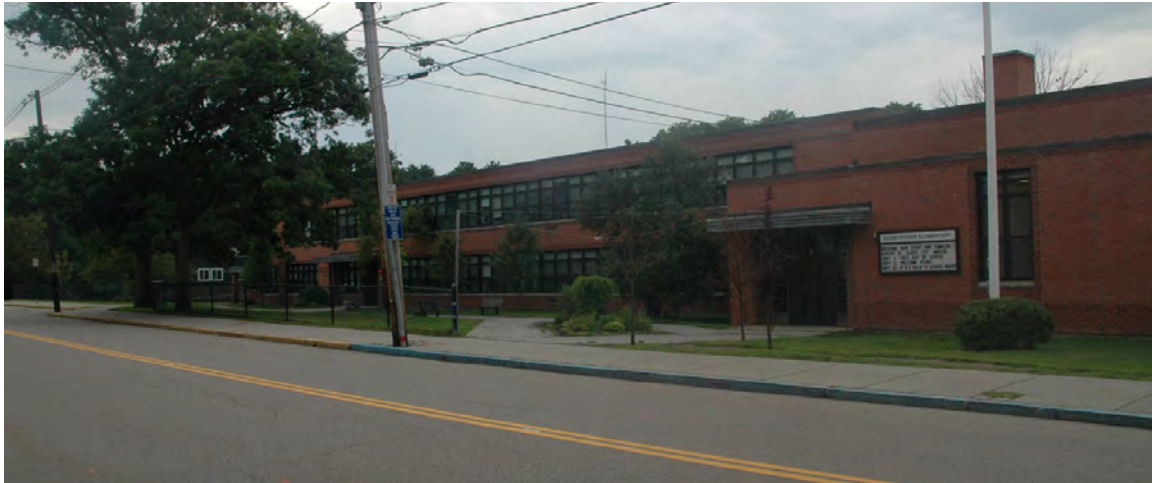
## Countryside Elementary School

*Openings:* Banks of horizontal windows with what appear to be replacement aluminum sashes.

Replacement aluminum entrance doors with sidelights and transoms.

Moderate. The building's appearance has been altered by the installation of the replacement window sashes and the aluminum fascia.

The building has a few architectural elements that place it within the Art Moderne style, which is not a common style for schools in Newton. However, it is not as distinctive as the two other schools in this style present in the City and its appearance has been altered through insensitive choices in replacement materials. Will gain in historic stature, but does not merit further investigation at this time.

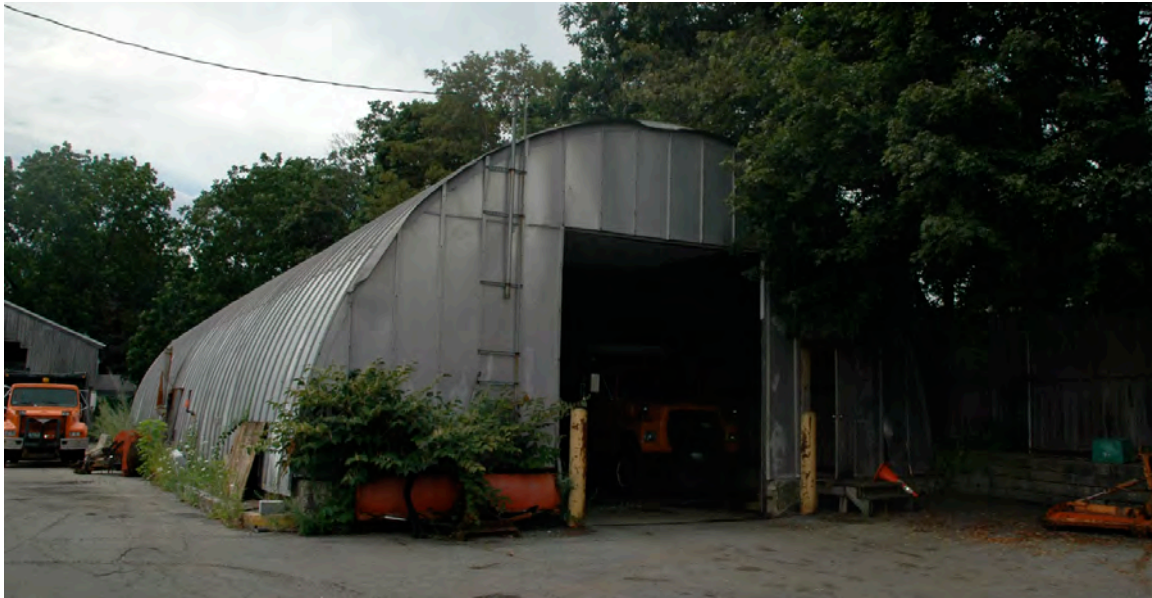
## Crafts Street Quonset Hut

Address: 110 Crafts Street  
Year of Construction: 1940s

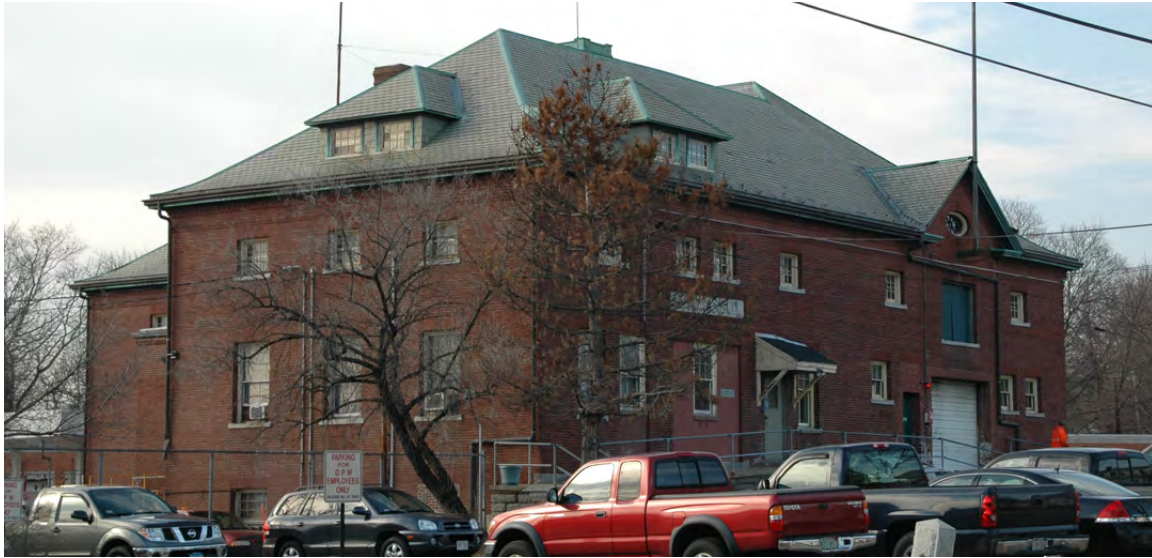
## Crafts Street Stable/Garage

*Materials:* Brick with granite and wood trim and granite foundation.

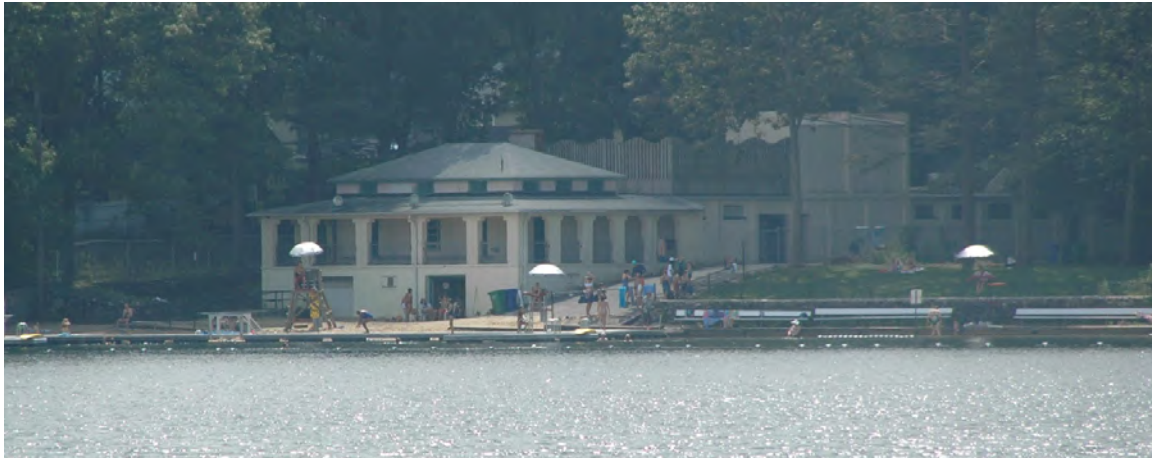
## Crystal Lake Bathhouse

Address: 44 Rogers Street  
Year of Construction: 1930

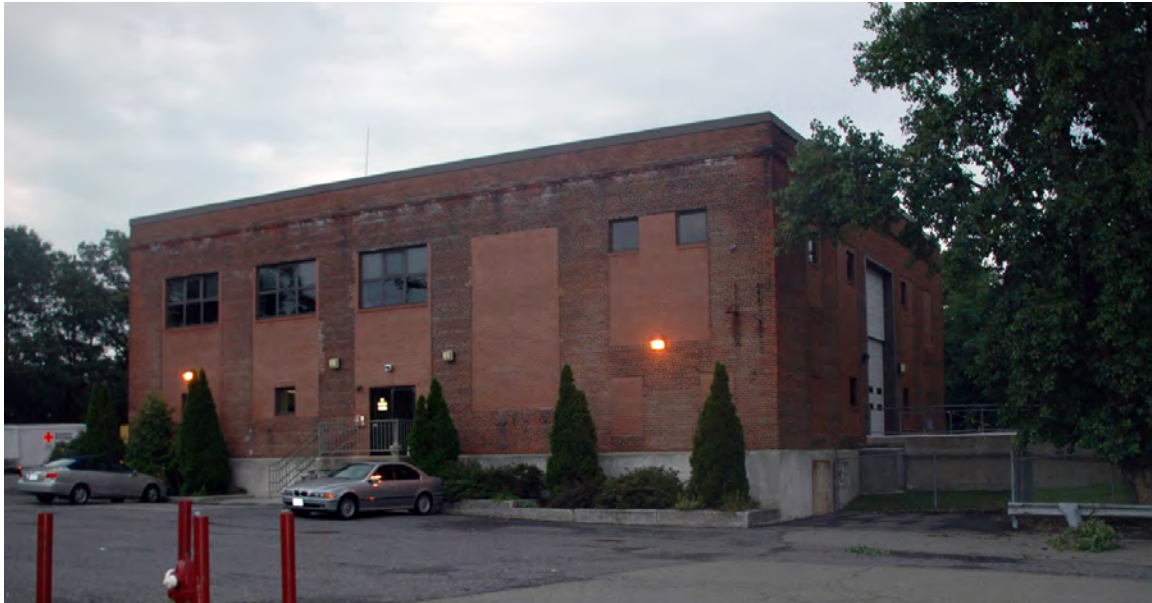
## **DPW – Water Utilities Department**

*Openings:* The building originally had large double-height openings that have been infilled with brick. Aluminum double hung and fixed windows have been installed within some of the infilled areas. A large double-height door opening at the side elevation has a modern replacement aluminum garage door and aluminum trim.

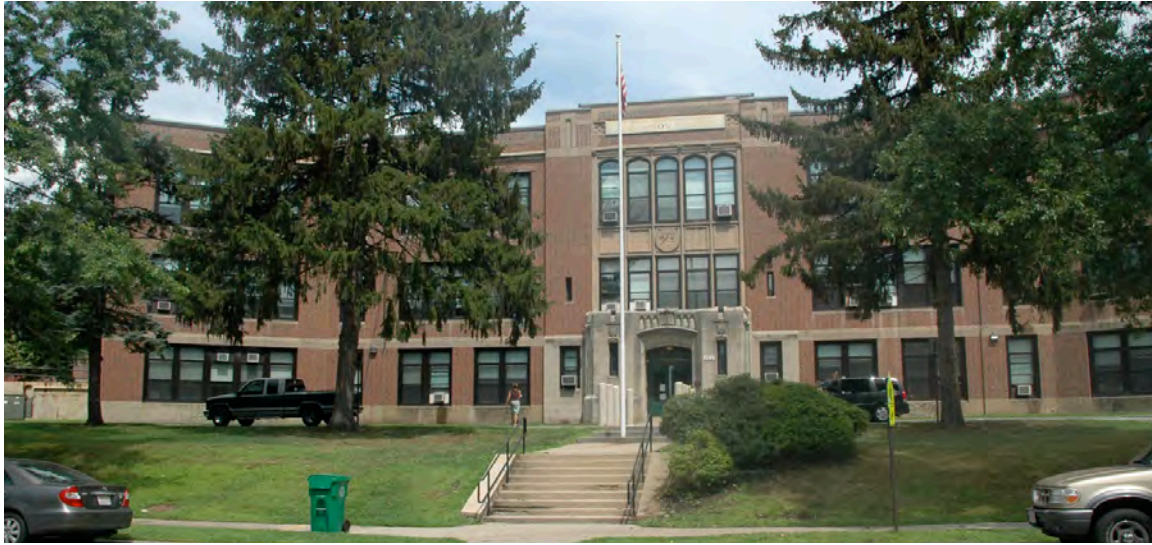
## Education Center

*Openings:* Typically horizontal bands of windows. Window openings are inappropriately infilled with aluminum replacement windows. The entry doors are wood set within an elaborate stone surround.

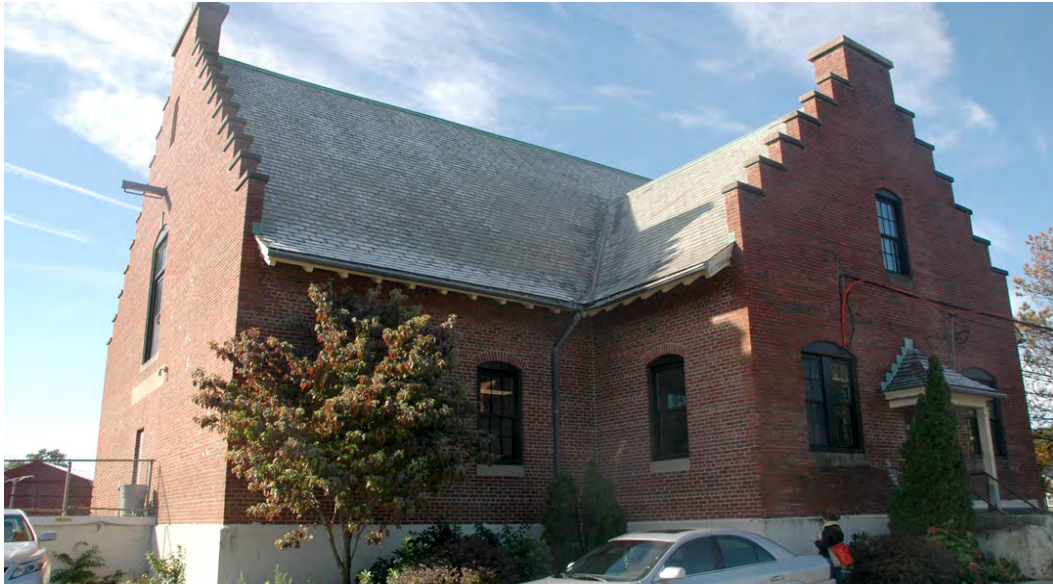
## Elliot Street Operations Center

*Materials:* Brick with stepped Flemish gable ends with stone parapet caps, painted concrete foundation.

*Openings:* Windows are typically single arched openings with replacement aluminum 6-over-6 sashes. A large arched window opening is located at the attic level of the gable end facing Elliot Street. The main entrance is in the side cross-gable and there are several secondary entrances, all with aluminum doors. The lower level has four garage bays. A concrete beam inserted in the street-facing wall indicates that there was once a large ground-level opening at this location.

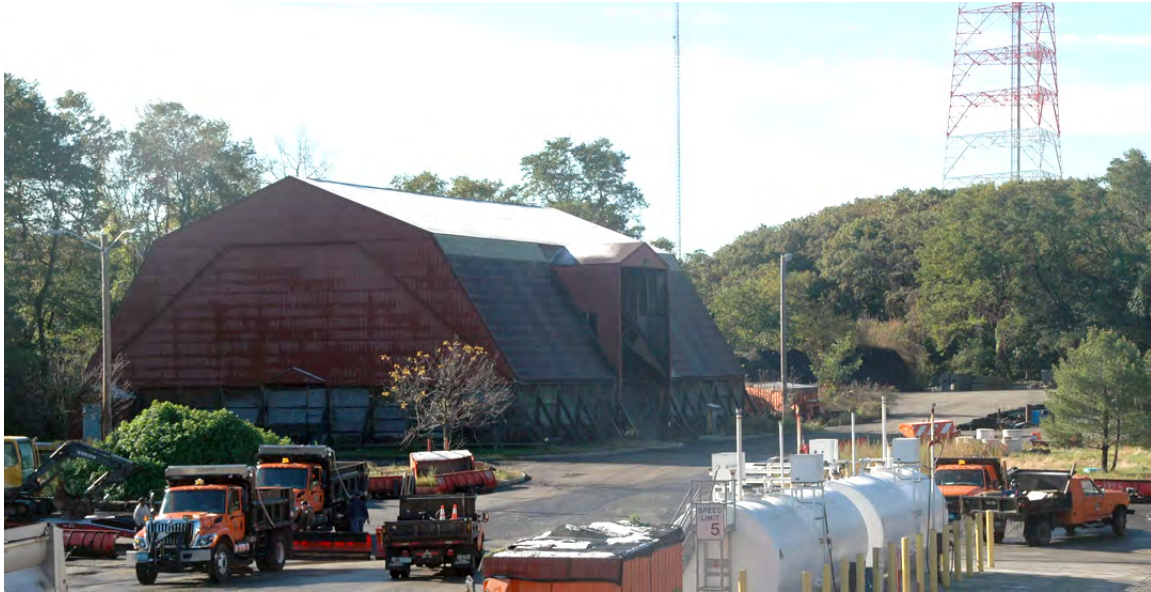
## Elliot Street Sand/Salt Shed

Address: 70 Elliot Street  
Year of Construction: 1994

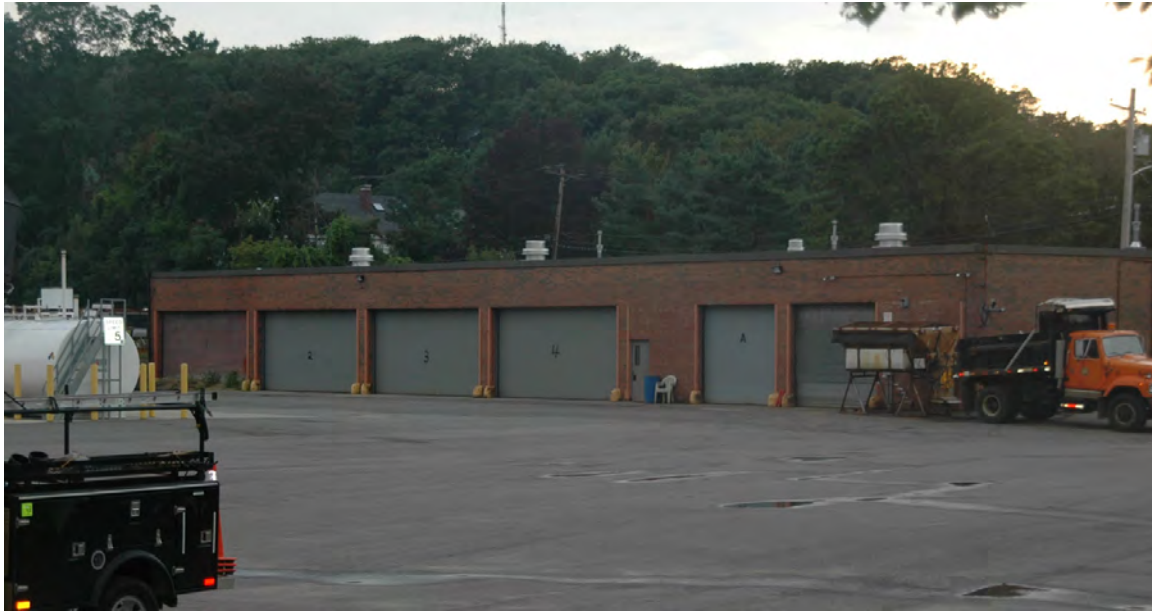
## Elliot Street Yard Garage

Moderate. The building appears to be substantially the same as when originally constructed, although it appears some of the garage doors may be replacements.

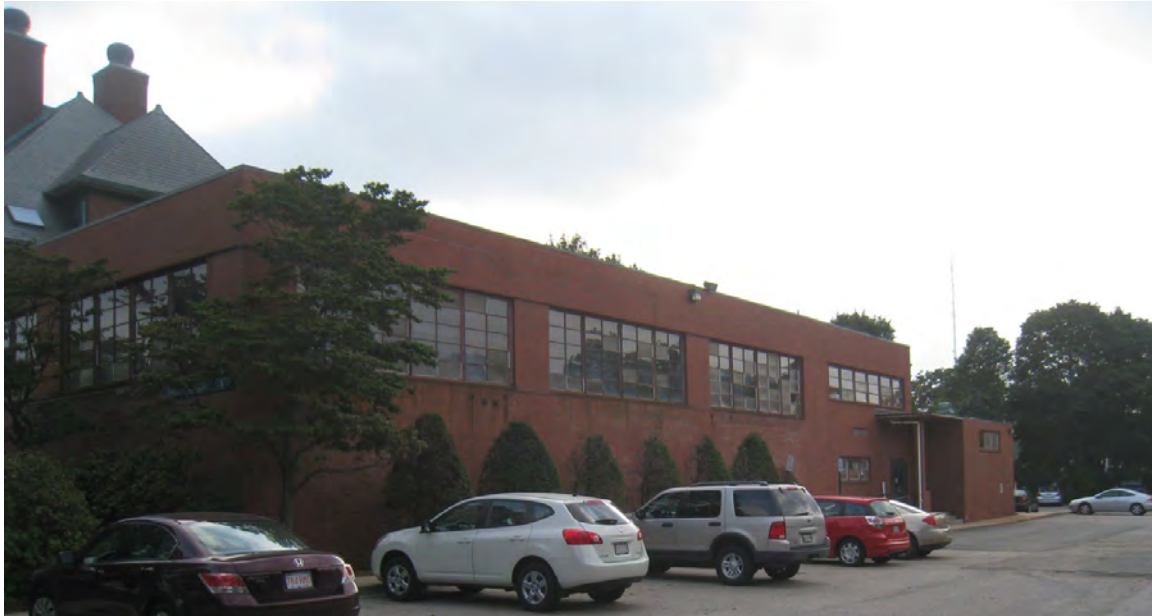
## Emerson Community Center

High. Still retains most of its original materials and design features. Has been poorly maintained leading to extensive damage to the brick.

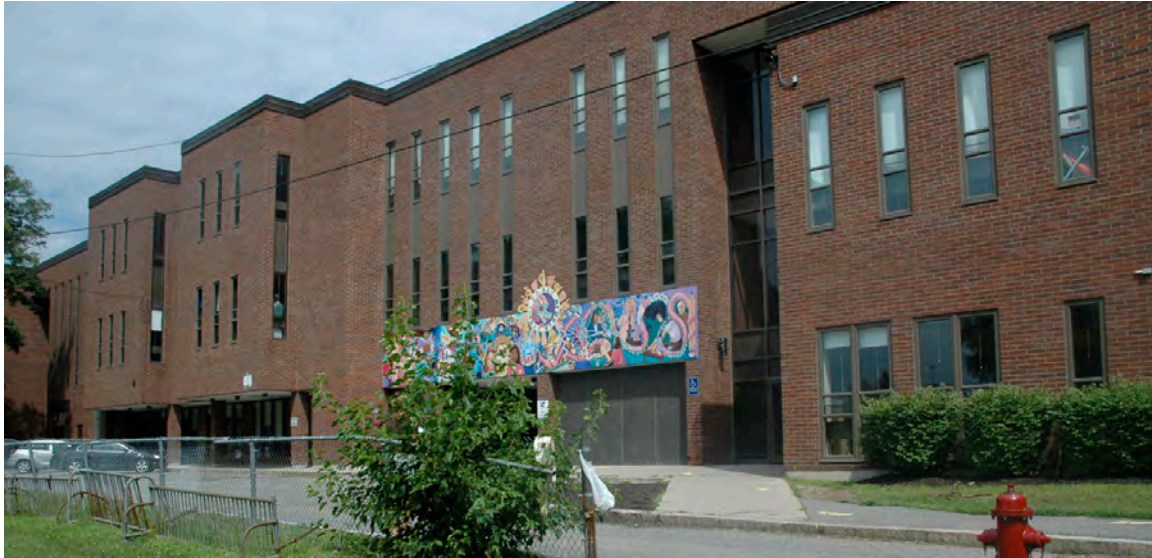
## F. A. Day Middle School

Address: 21 Minot Place  
Year of Construction: 1971

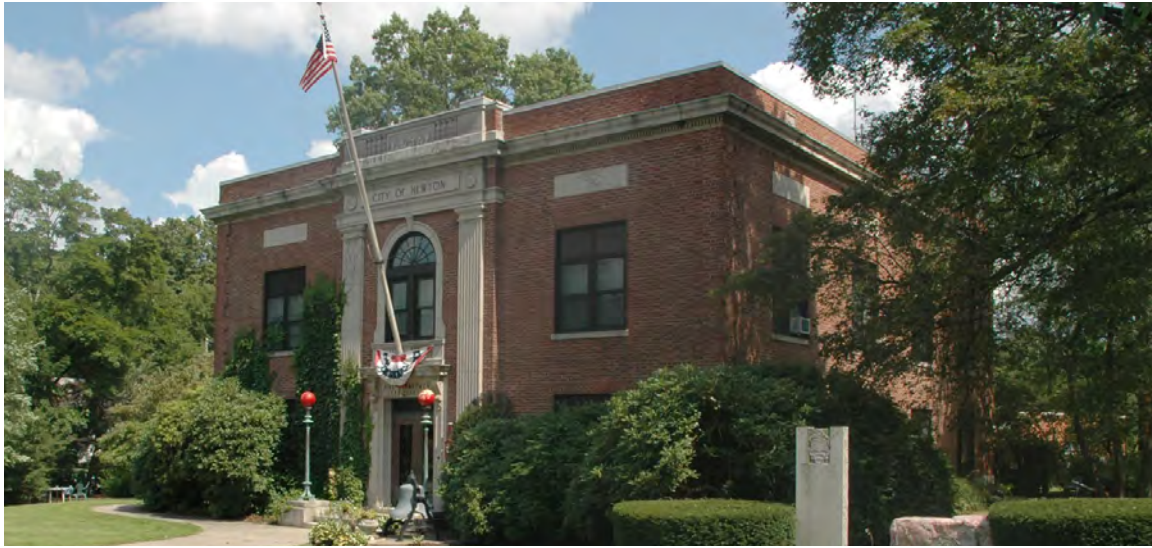
## Fire Department Headquarters

*Openings:* Typically large rectangular openings with aluminum replacement windows set in pairs of double hung sashes with fixed transoms. The window over the main entrance is in an arched opening. The main entrance retains what appear to be the original bronze doors.

High. The building retains the majority of its original materials and design features with the exception of the replacement window sashes.

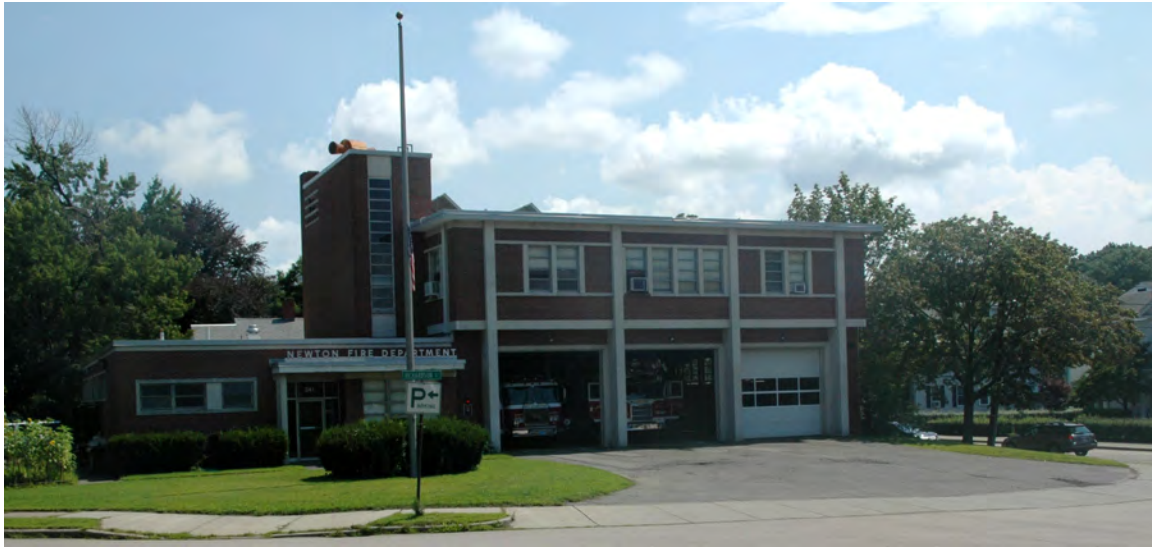
## Fire Station #1 (Newton Corner)

Address: 241 Church Street  
Year of Construction: 1965

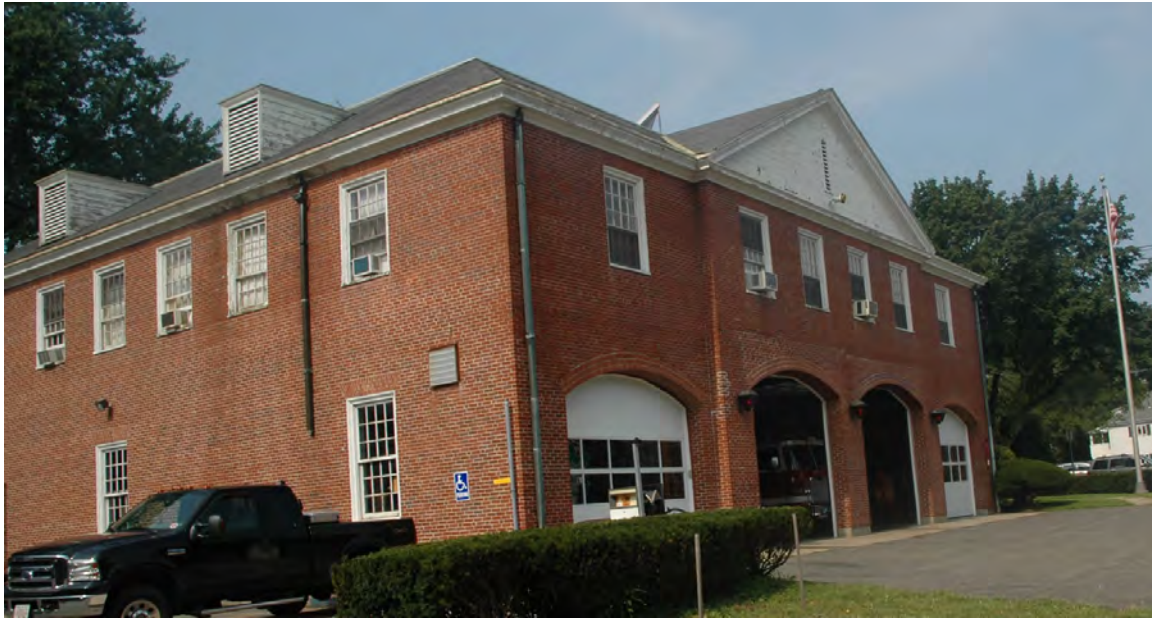
## Fire Station #2 (West Newton)

*Openings:* Horizontal bands of windows that retain what appear to be their original window sashes and metal infill panels. The garage doors of the main building appear to be later replacements.

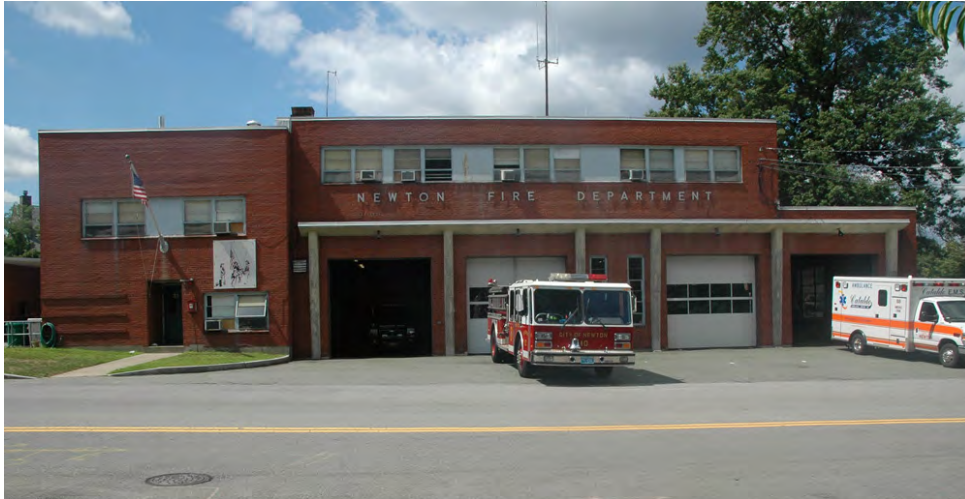
## Fire Station #3 – Newton Center

Address: 31 Willow Street  
Year of Construction: 1955
